CHURCH IN WALES
QUINQUENNIAL INSPECTION

**ST. ELLDEYRN CHURCH,
LLANILLTERN**

**Morgan & Horowskyj Architects
The Schoolroom,
Castle Street
Abergavenny,
Monmouthshire.
NP7 5EE**

September 2018

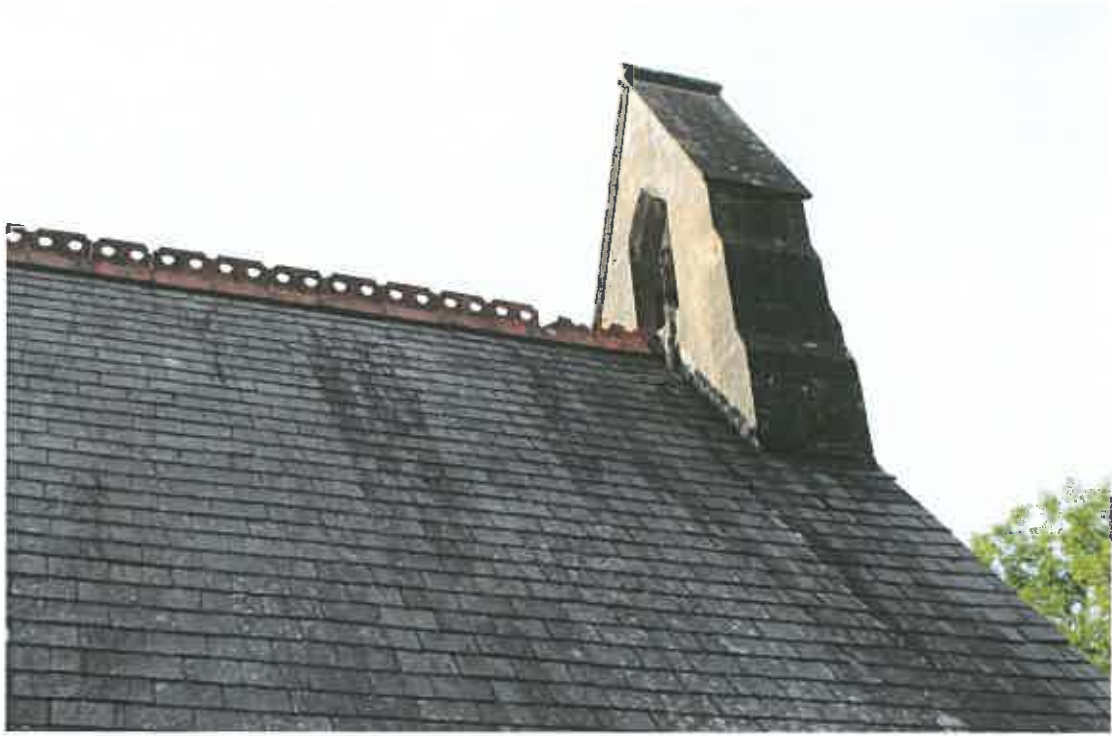
On the south side of the Chancel there is a slate roof and apart from some loose slates which were “kicking up” was generally in good order. There are red Victorian crested ridge tiles and some mortar has been lost from the bedding of the tiles and requires replacement. To the south side of the Nave again there is a slate roof which is in good order. There are Victorian ridge tiles two of which are broken beside the bellcote.

Broken ridge tiles beside the bellcote.

- Refix or replace loose or missing slates.
- Replace damaged ridge tiles and generally rebed loose ridge tiles in lime mortar.
- Remove plant growth from the walls and roof.
- Hack out and repoint mortar fillets behind copings.
- Upgrade leadwork around the bellcote.
- Touch up rainwater gutters and clear out surface water drains.
- Add gullies and soakaways to serve the downpipes on the south side of the Church.
- Stabilise table tombs and headstones in churchyard.
- Provide fence along the east boundary at change in level or provide warning signs for visitors.

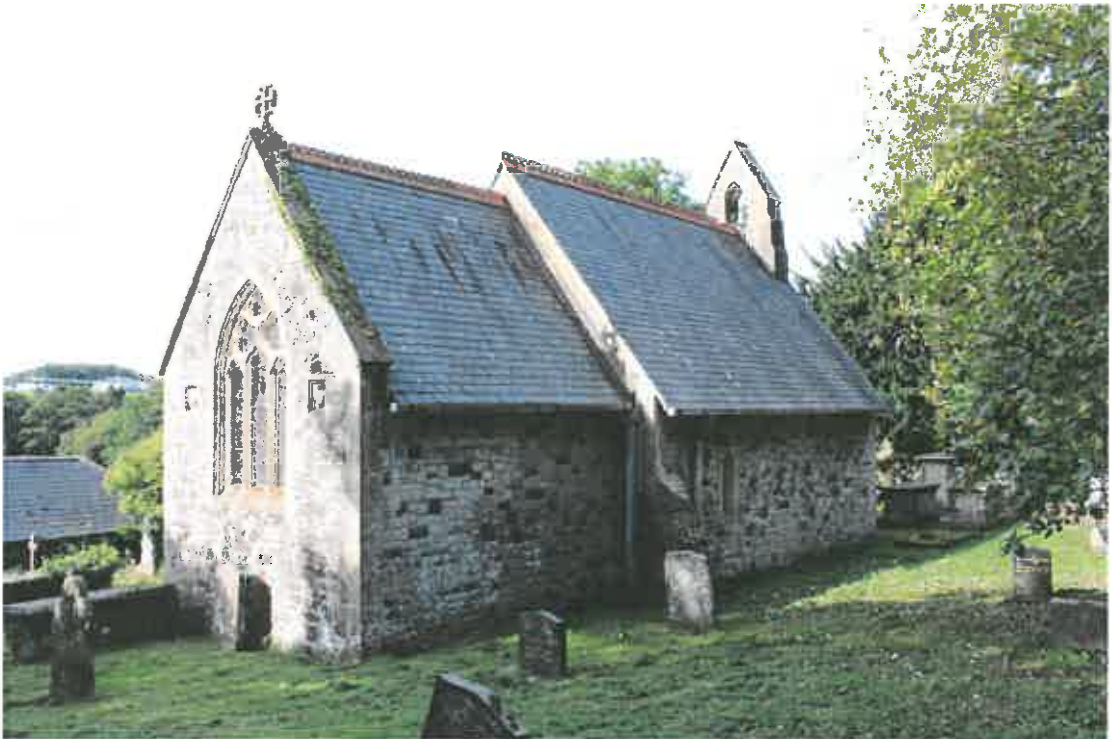
North side of Church from the North East corner.

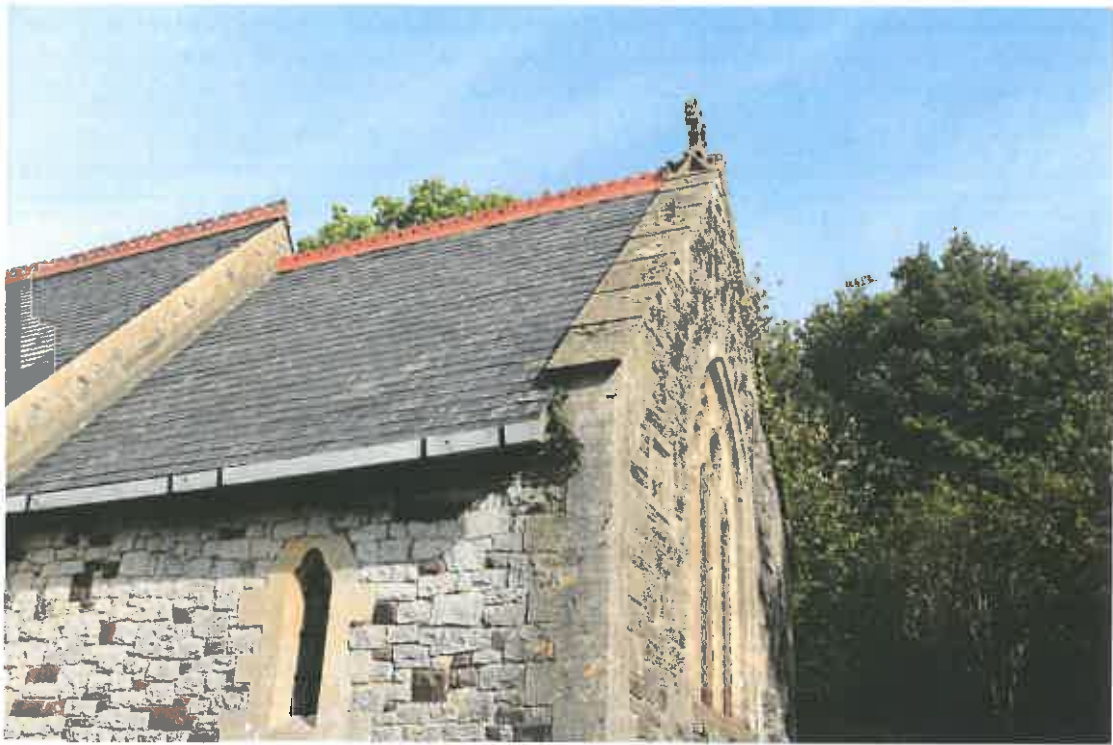
Plant growth at the South East corner and repointing needed under the ridge tiles.

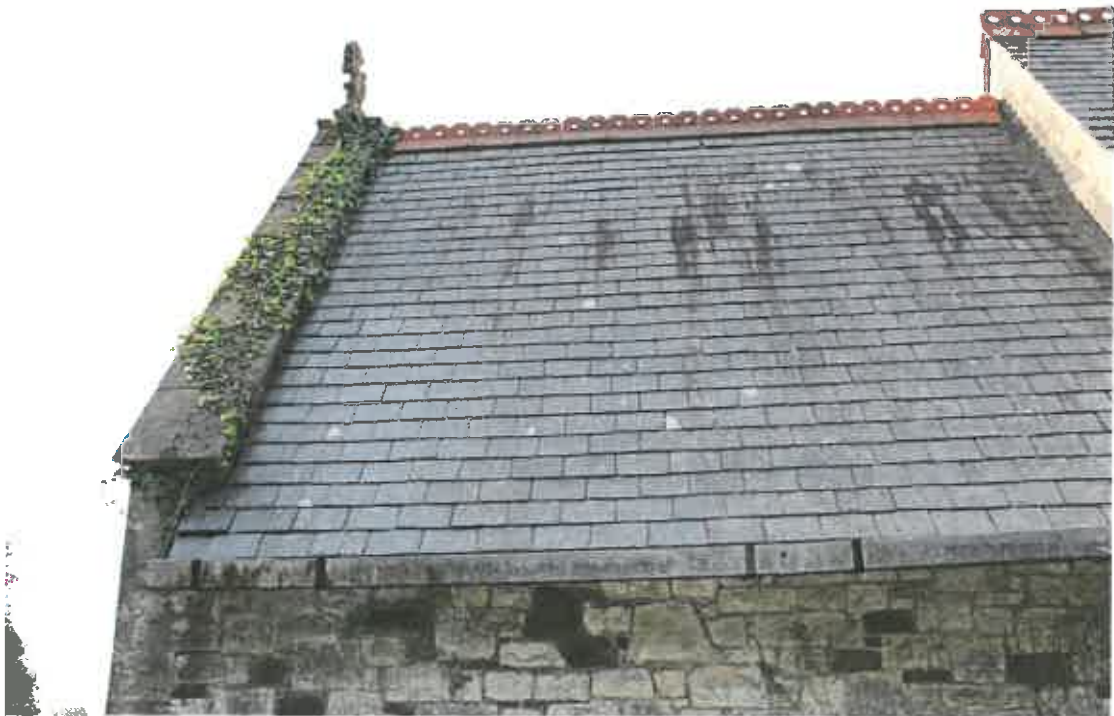
Plant growth on the North slope of the East gable. Rainwater gutter rusting and in need of painting.

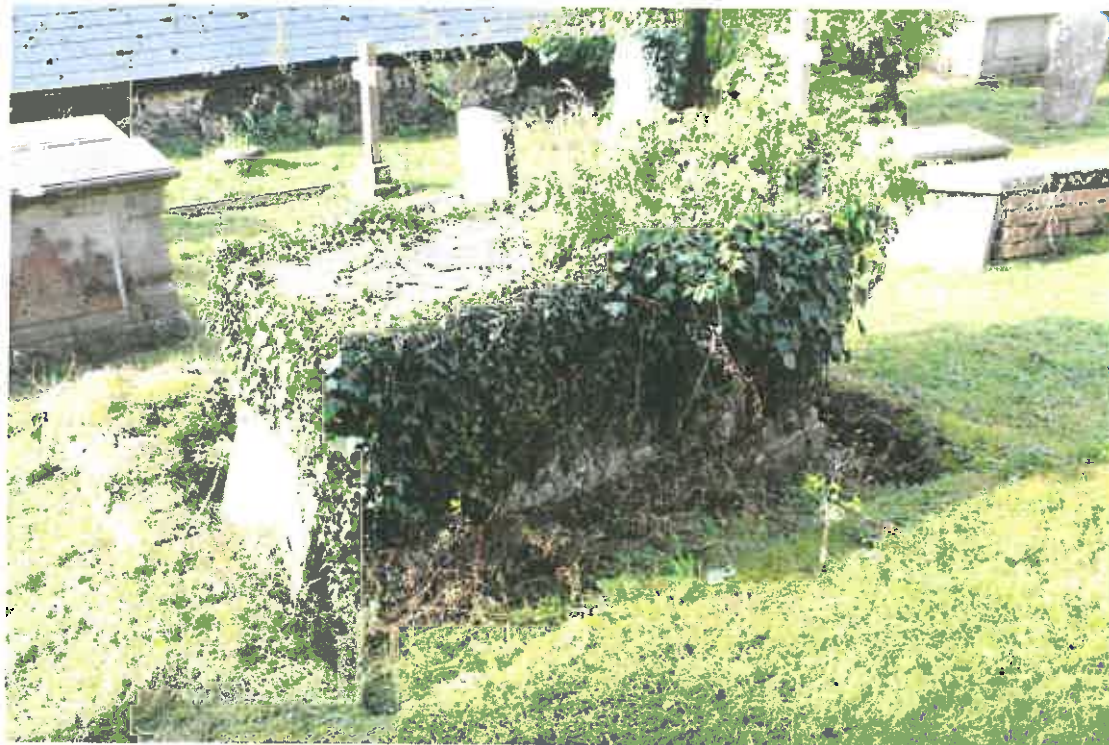
Table tomb overgrown with ivy and unstable.

On the churchyard side of the south wall its height is approximately 1 metre. One of the table tombs situated next to the wall has subsided and needs to be taken down and re-erected. Midway along the south boundary there is another stile with steps giving access into the adjoining private property. From this stile to the south east corner there is a party wall shared with the adjoining property and a low slate roof and gutter overhanging the churchyard. There is dense plant growth along this wall which needs to be cut back and a further table tomb near the south east corner has become unstable.

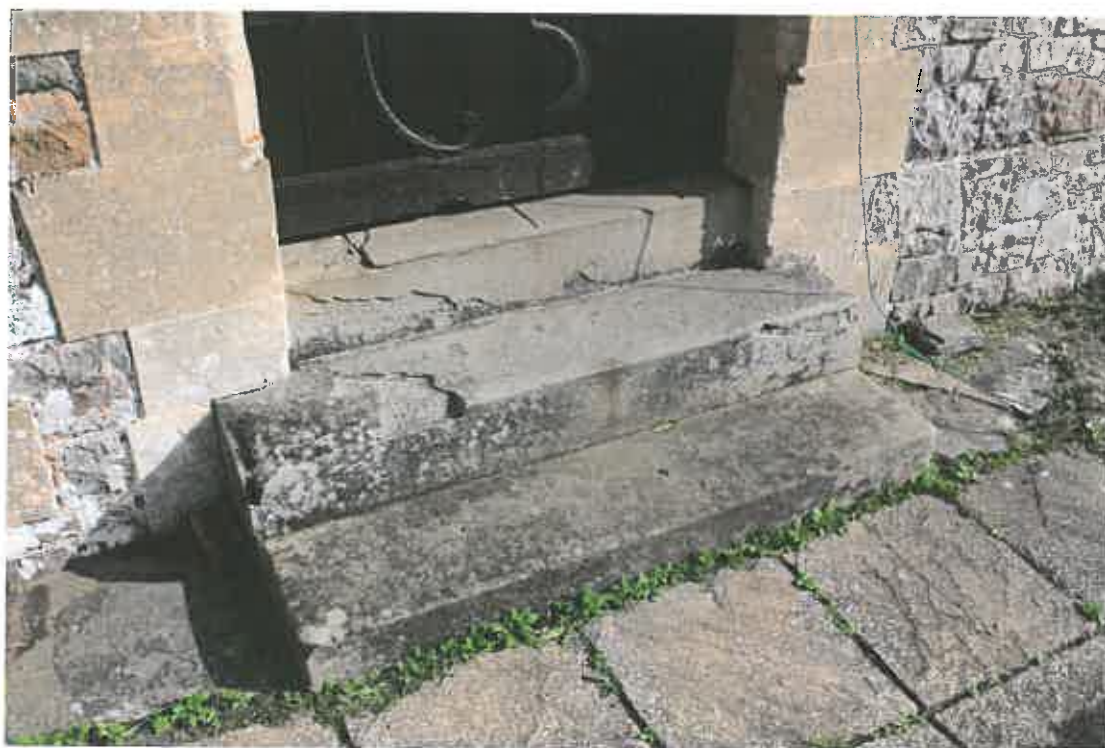
Shaling to the stone steps in front of the South door.

repainting. There are three steps leading into the Nave and some shaling has occurred to the top two steps and requires minor repairs.

- Carry out minor repairs to steps in front of south door.
- Replace rotten rafter ends at the north east corner of the church.
- Refurbish the reredos including rebedding of capping and repointing of Ashlar stonework.
- Replace cracked and broken quarry floor tiles.
- Repair uneven surface to the floor at the west end of the Nave.
- Repair step to pulpit.
- Cut back ivy growth from churchyard walls.
- Hack out and repoint boundary walls.
- Rub down and redecorate pedestrian gates and railings around memorial plots.
